### Fire Door Assembly Inspection Report

**Property** Riverside Hotel **Date** 9/13/2026  
**Address** 100 Example Ave  
Hartford, CT 06103 **Inspector** Joe  
**Customer** Riverside Hospitality Group

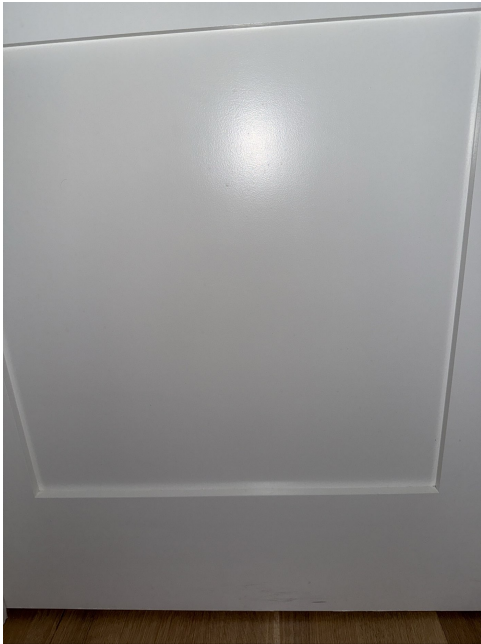
Before

| Glazing, vision light frames and glazing beads are intact and securely fastened in place, if so equipped | <b>FAIL</b> |

### **CRITICAL** Door FD-001 — Stair A, ground floor

- Glazing, vision light frames and glazing beads are intact and securely fastened in place, if so equipped

NFPA  
80

### **Resolved in Field**

Fixed

Resolved by Joe · 9/13/2026

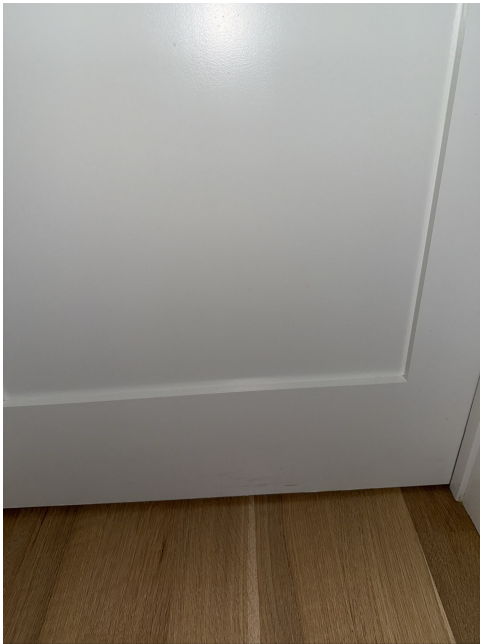
Before

| Clearance under the bottom of the door | 1 in. |

**CRITICAL Door FD-003** — Corridor B cross-corridor pair

- Clearance under the bottom of the door: 1 in. (no more than 3/4 in.) — corrected

NFPA 80

**Resolved in Field**

Yes

Resolved by Joe · 9/13/2026
